**NASA CONTRACTOR
REPORT**

NASA CR-2122

**ANALYTICAL AND EXPERIMENTAL INVESTIGATION
OF AIRCRAFT METAL STRUCTURES
REINFORCED WITH FILAMENTARY COMPOSITES
Phase III - Major Component Development**

BOEING COMMERCIAL AIRPLANE COMPANY

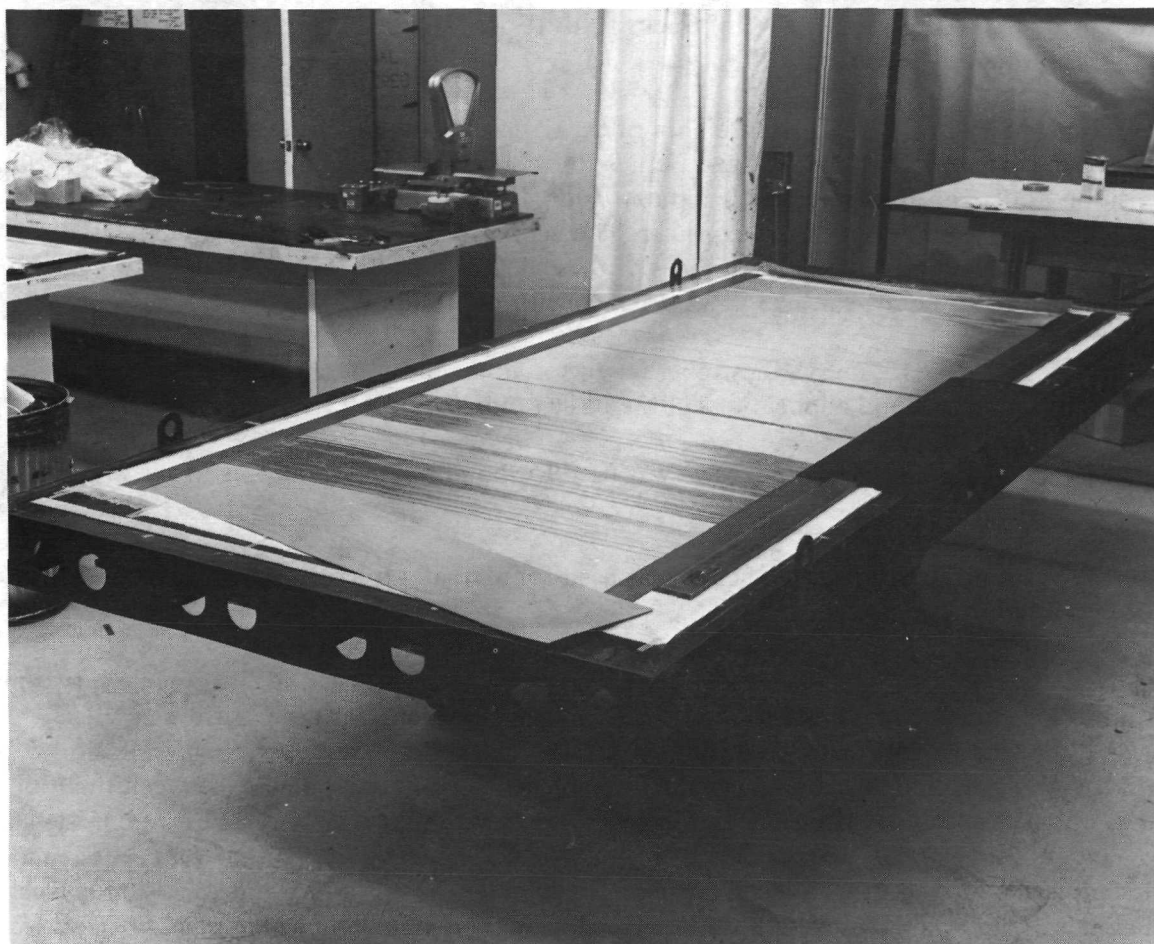
FIGURE C-2.—LAYUP OF BORON-EPOXY REINFORCEMENT LAMINATES

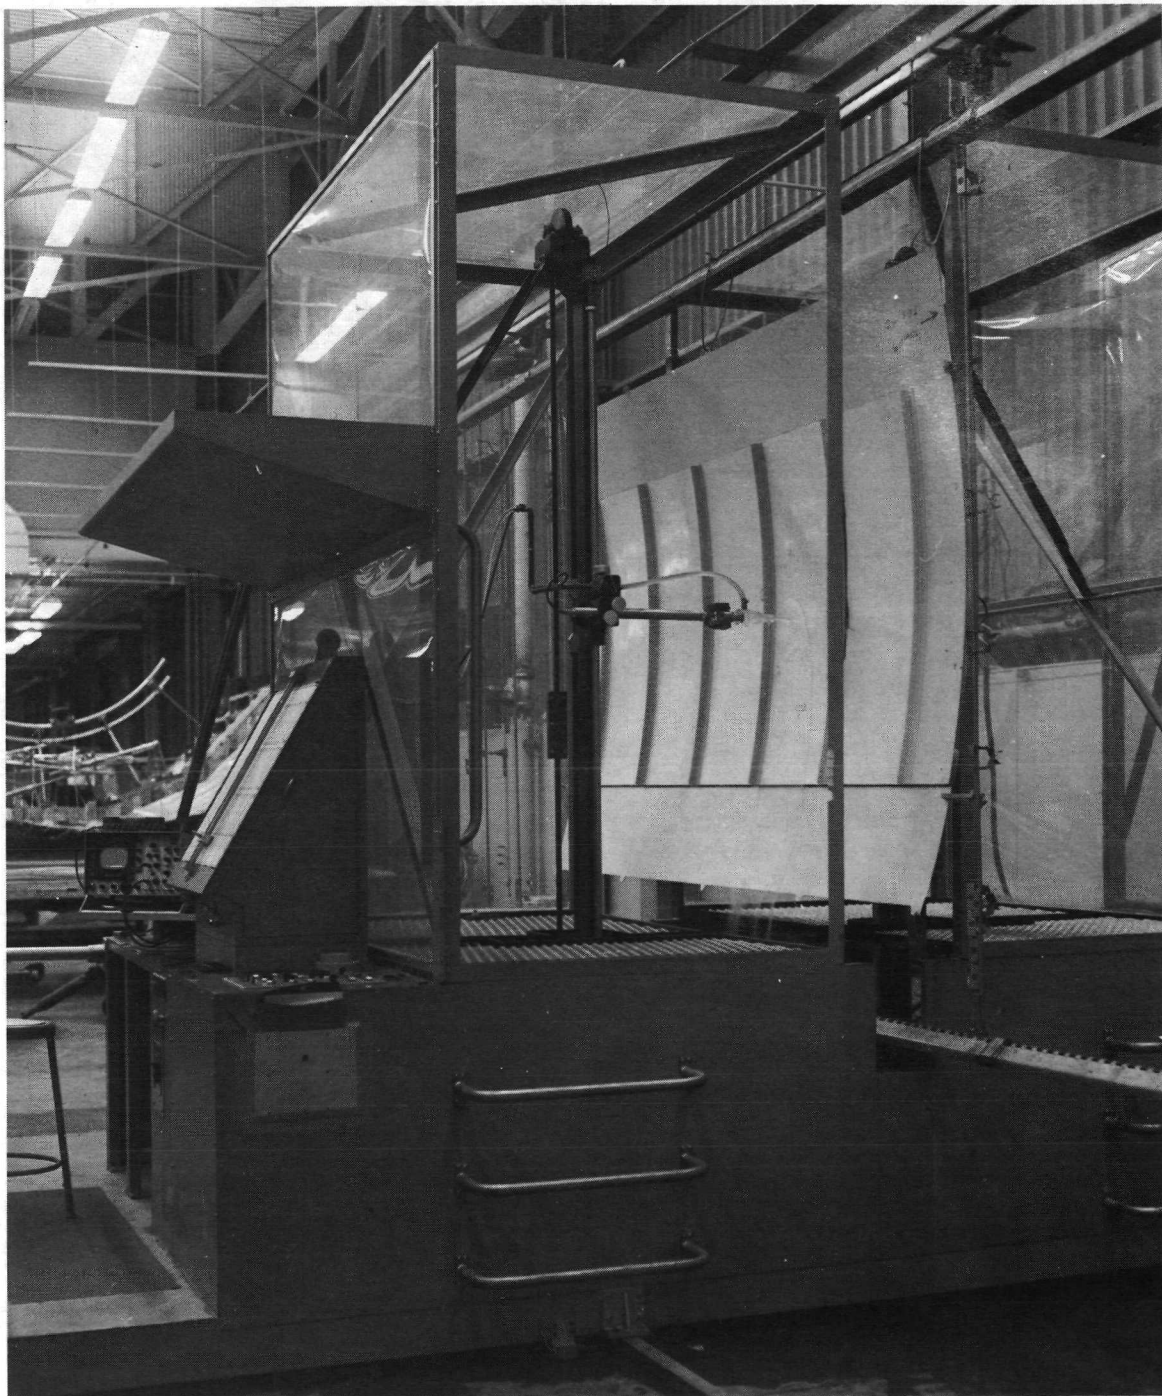
**FIGURE C-4.—ULTRASONIC THROUGH-TRANSMISSION INSPECTION OF FUSELAGE
DAMAGE CONTAINMENT PANEL**

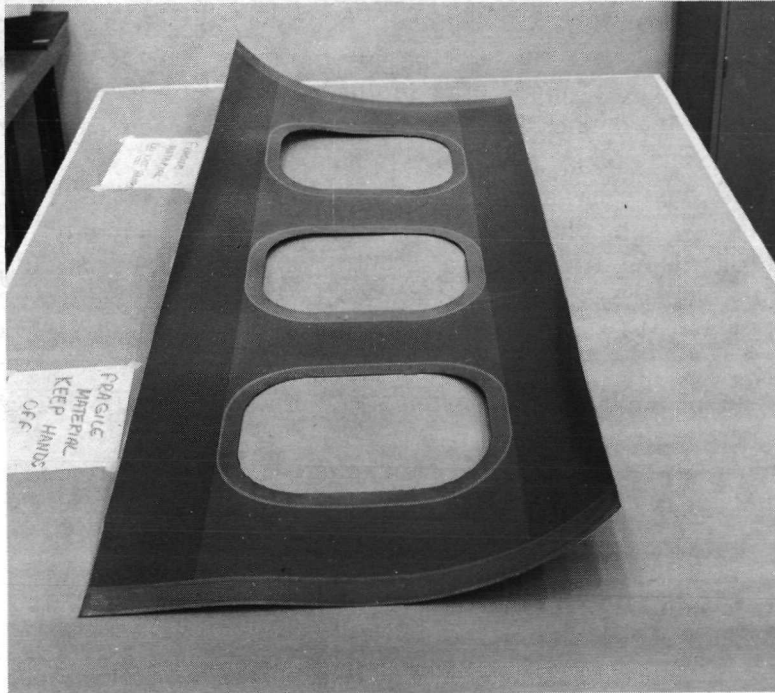
FIGURE C-11.—SECOND-STAGE BORON-EPOXY LAMINATE

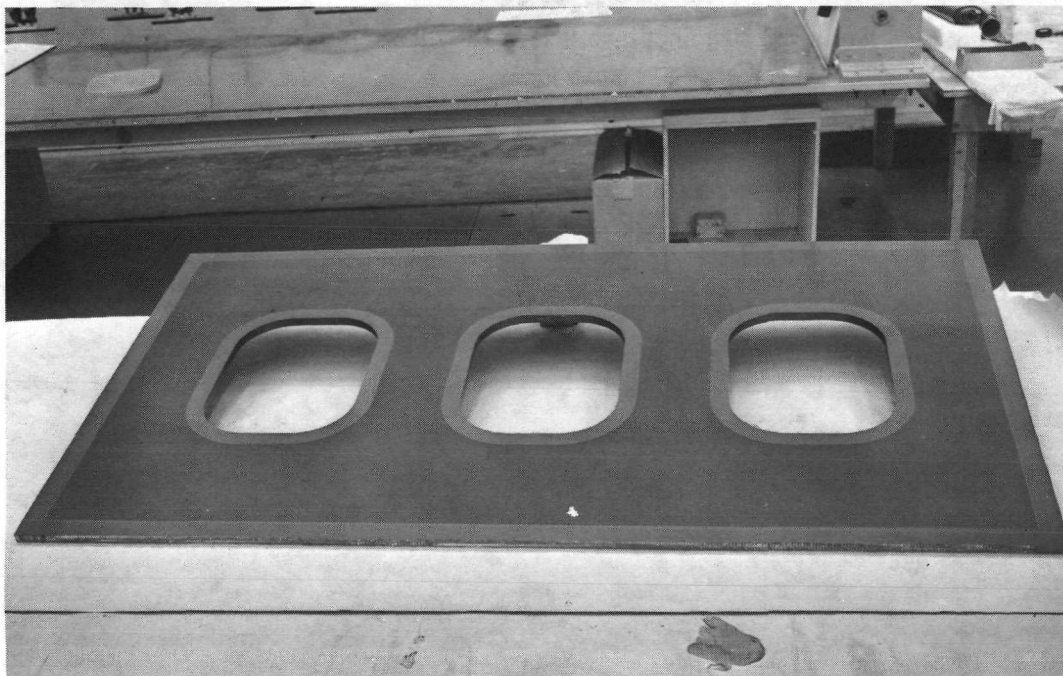
FIGURE C-13.—PREASSEMBLY OF COMPOSITE SKIN-BLANKET CORE AND WINDOW FRAME PLUG ASSEMBLY
